Stewardship Success Story:

Rogue Creosote Log Removal

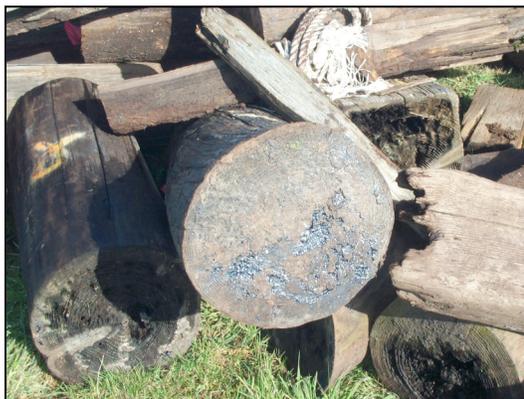
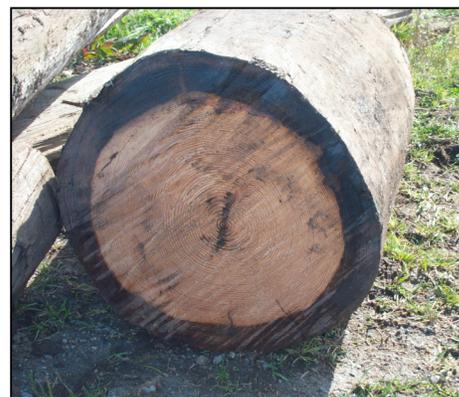
Rogue logs are those whose origins are not known.

The 24-acre Sullivan-Minor salt marsh was mudflat or salt marsh that was diked and drained in the early-to-mid 1800s. The dike fell to disrepair sometime in the early 1900s and all that remains of the dike is a berm on the outside of the marsh. There is a log dump in the northeastern corner and a freshwater channel (storm water runoff) that is often plugged at its mouth. The creosote logs occur on the berm, in the salt marsh behind the berm, and in the log dump area.

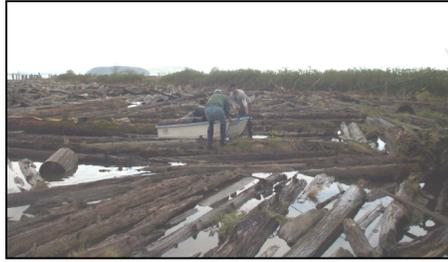
A local contractor was hired to do this job. The contractor skidded the logs over the log jam area and up the slope on the north end, near the access stairs. Pieces were placed in a fiberglass skiff and winched up the slope, using an electric winch mounted to a flatbed trailer. Chokers were placed on larger pieces and pulled up slope via truck using rope and pulleys. Most of the larger pieces were bucked at the top of the slope, near the road.

The logs were then loaded with a backhoe into a disposal container (8' x 8' x 48', obtained from Regional Disposal Company in Ferndale, WA). The container was trucked to Regional Disposal Company and shipped via rail to the Rabanco hazardous waste site in Roosevelt, Washington. Reserve staff restored the "skid road" with native plantings.
